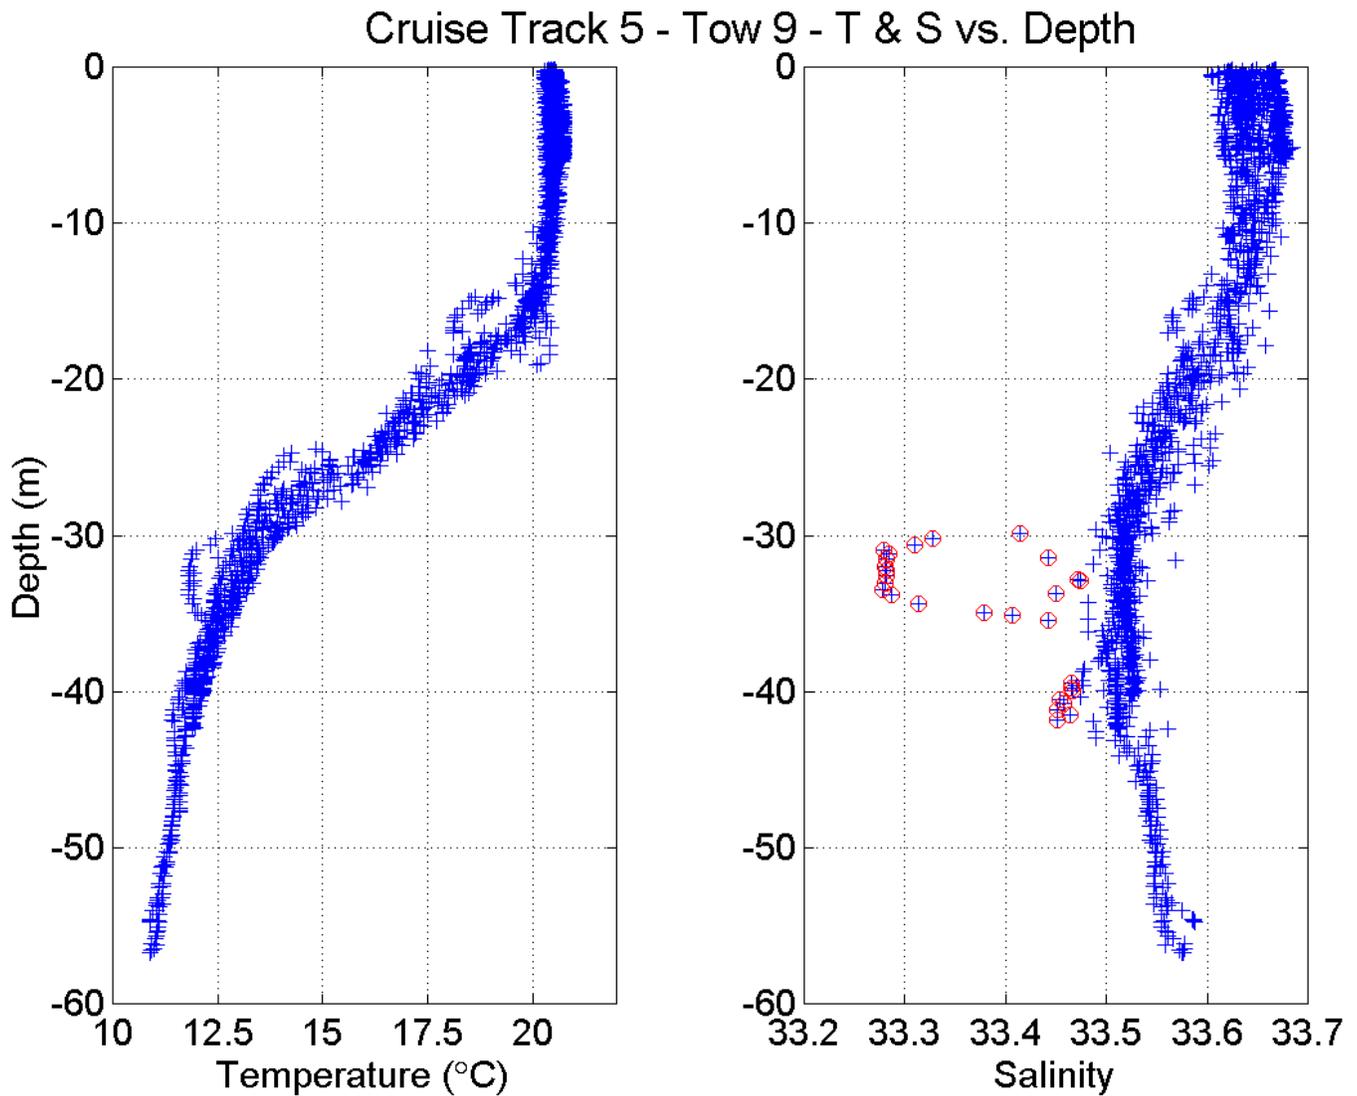
Figure 2-6. Vertical profiles of temperature and salinity for all of the one-second average data for Tow 9 from Cruise 5, a subset of the data shown in Figure 2-5. The red circles in the salinity profile indicate the measurements where the salinity anomaly is less than -0.01 psu (i.e., the measured salinity is more than 0.01 psu less than the predicted ambient salinity based on the T-S equation for this temperature region). Note that there are no salinity anomalies near surface indicating that in this particular tow there was no evidence of surface runoff in the upper layer.
